Conservation Project Report

Grand Staircase Project

Overview

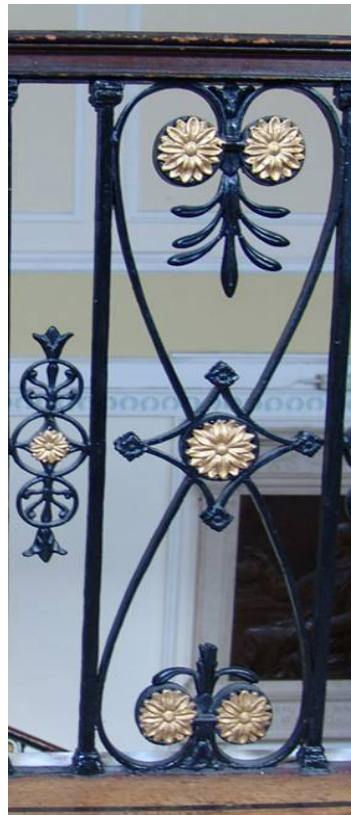
Detail of staircase banister.

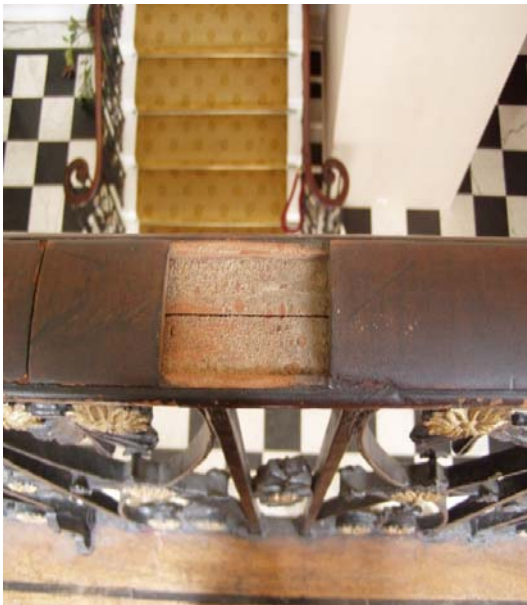
The handrail was originally constructed using lengths of mahogany, moulded and shaped on both sides, with additional short grain domed sections of mahogany inserted into the top.

A missing panel from domed top of handrail

The restoration process involved replacing the badly damaged sections with “new” pieces of period mahogany. All of the inserts were repositioned and the missing areas replaced.

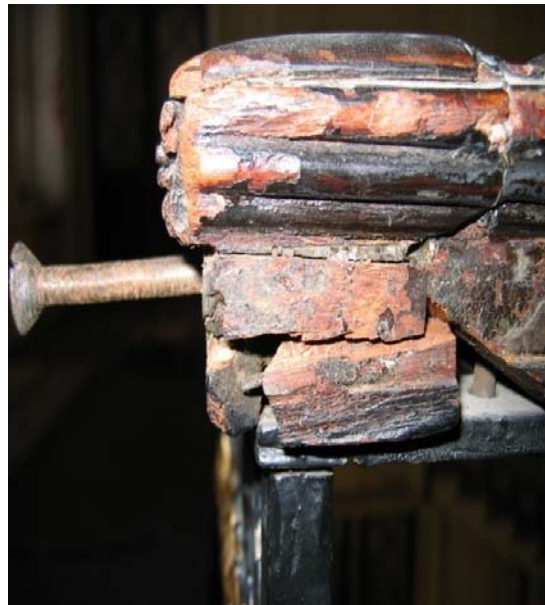
Damage to the handrail corner including an old repair.

The mahogany inserts had become loose having shrunk, and in some areas had been replaced. Where the handrail was jointed, all the corners were badly damaged and further attempts to repair these areas had only weakened the structure further.

The handrail was positioned back onto the restored metal balusters with all new sections then being carved to match the surrounding areas. The structure was unstable and major damage had occurred to the corners of the wooden structure meaning they would have to be rebuilt. After discussion between all parties it was decided to re-enforce the corners with small metal pieces, as shown in the image above.

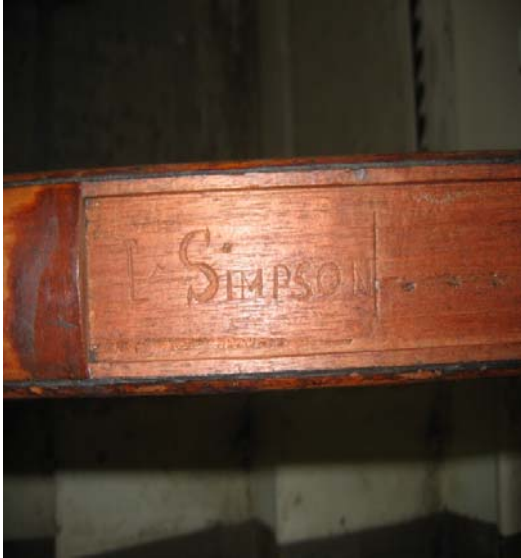
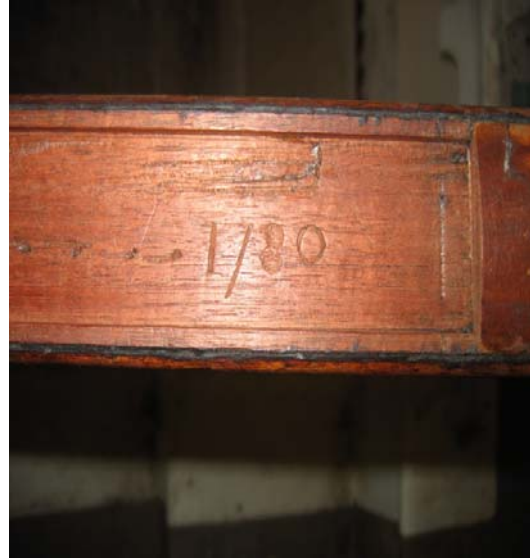
During the project the signature I. Simpson and the date 1780 were found on the bottom left hand side inside the original structure. It was often common practice to include a signature while producing the original design and confirms the dating of the handrail to the Georgian period.

The carved name and date discovered on the underside of the handrail

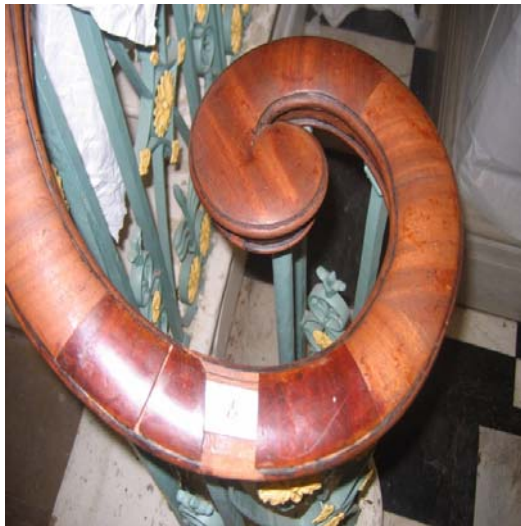
Panels on top of handrail before and after treatment

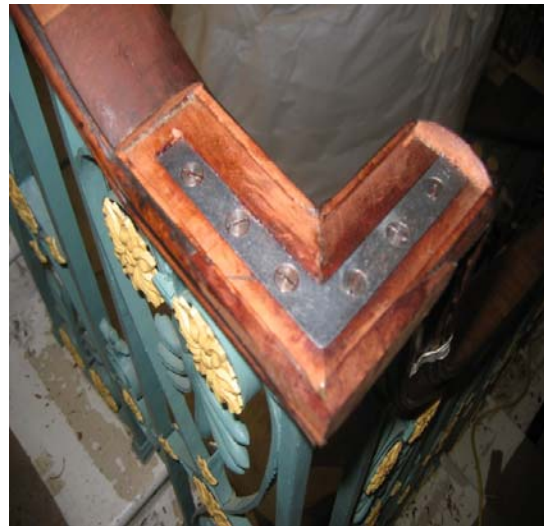
Reinforced corner to provide structural stability.

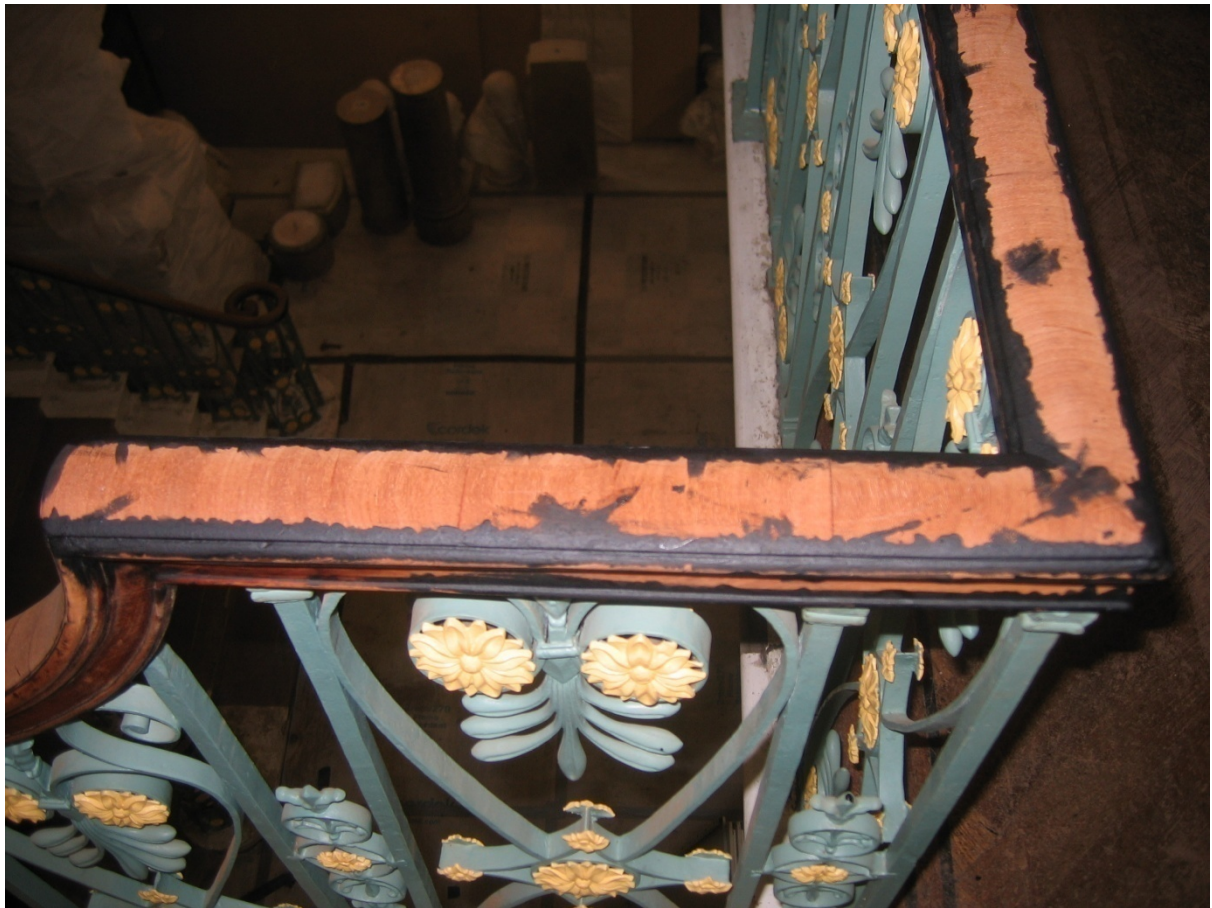
The wooden handrail back in place on the conserved metal banister.

The final stage was to preserve the original patination and to blend the new inserts to match the original material.
